## Technical Bulletin # 7

# Bore Decommissioning in the Dryland Mallee

From 1993 to 2003 a decommissioning program was undertaken in the dryland Mallee to decommission old bores that were known to have failed. Decommissioning these bores aimed to reduce contamination of saline groundwater from the Parilla Sands Aquifer into the fresher Murray Group Limestone Aquifer.

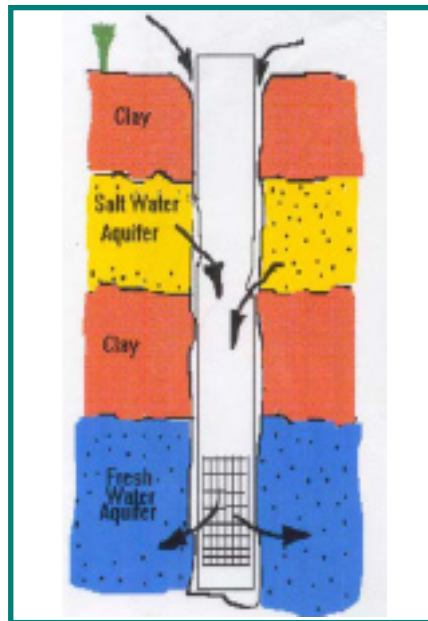
Diagram 1. Shows the failure procedure for the old bores where saline groundwater from the upper aquifer passes through holes in the bore casing to the lower fresh water aquifer, thereby contaminating it.

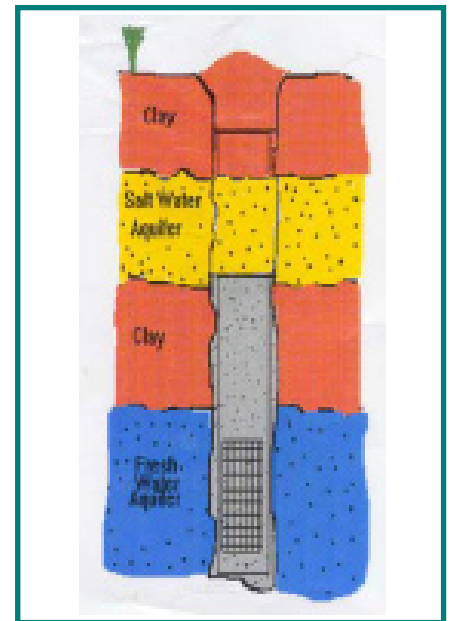
Diagram 2. Shows the bore shown in bore casing filled with cutting cement grout thus off any avenue for groundwater from the upper aquifer passing through holes in the casing to the lower better quality aquifer.

Drilling contractors were appointed to decommission the bores. The bores were drilled down into the old bore casing. Surplus mud and material was removed and then the bore was filled with cement mortar mix. A number of bores had obstructions including star picket posts and stones. This made the bores difficult to decommission and required a second attempt with more sophisticated equipment. Contractors used 'wash-over string' technology to drill down the outside of the bore casing and withdraw the whole casing.

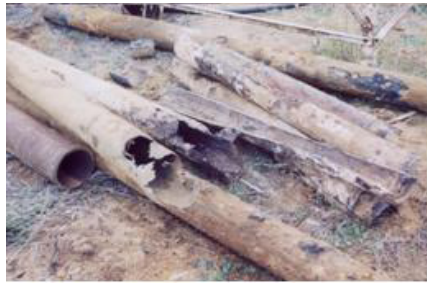
Above: Bore casings removed by the jacking procedure. The deterioration of the bore casings is clearly visible.
